SUMMIT LAKE DAM

NDI ID NO. PA-00291

PHASE I INSPECTION REPORT.

APRIL 1979

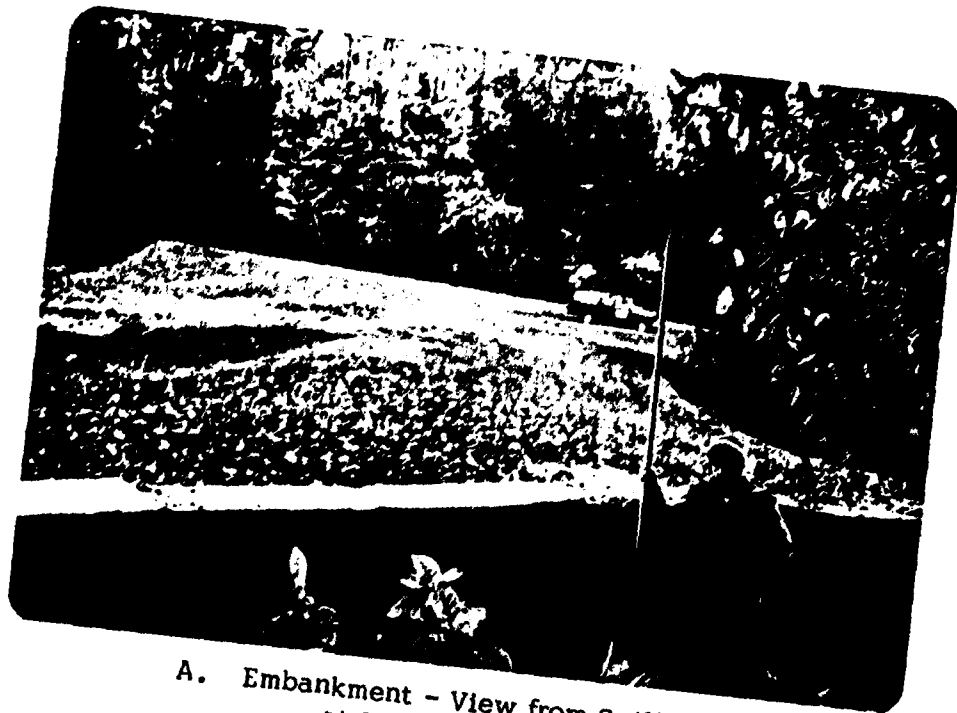
A. Embankment - View from Spillway  
at Right Abutment

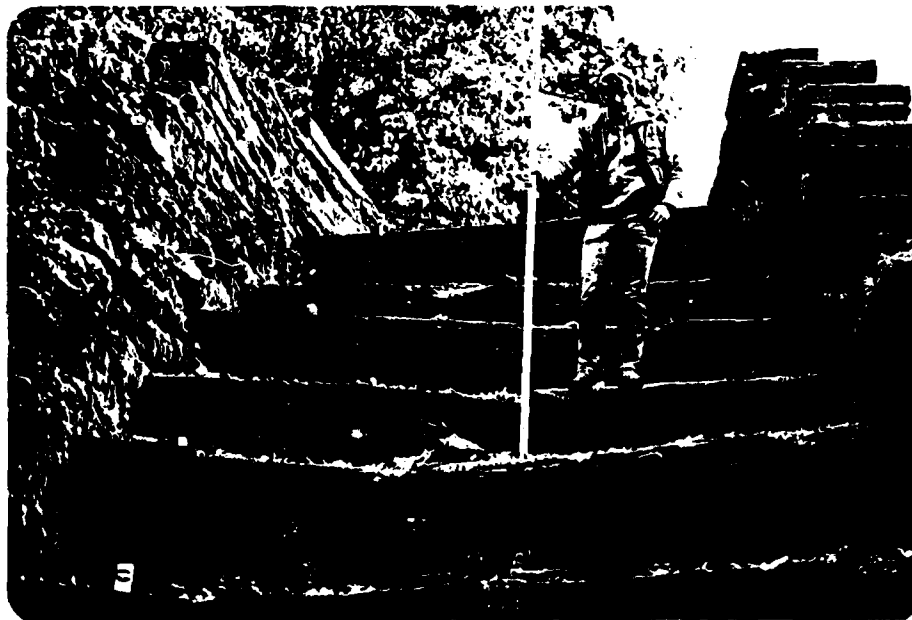
(3) Appurtenant Structures. No deficiencies of structural significance were observed at the outlet works. Most of the deficiencies at the spillway are an indication of lack of maintenance. The sagging of the cascade steps is of some concern. It is believed that this could have been caused by poor construction practice or foundation problems. As the construction information is very limited, the cause cannot be ascertained without further investigation. The 1914 Pennsylvania Water Supply Commission Report notes that in 1911 one of the walls along the cascade had to be reset because it had settled. The Report indicated that the spillway cascade is founded on earth.

| VISUAL EXAMINATION OF | OBSERVATIONS | REMARKS OR RECOMMENDATIONS |
|---|--|--|
| DISCHARGE CHANNEL | MASONRY CASCADE<br>DETERIORATED MORTAR<br>SAGGING IN MIDDLE. | |

F. Spillway Cascade

(3) Monitor with any suitable means the sagging spillway cascade steps. If changes are noted, take immediate remedial measures.
